# Manhole Inspection Summary

Manhole # S59K\_\_007MH

Insp Date: **7/24/08 8:04 AM**

**Location** Address: **4500 fait ave**

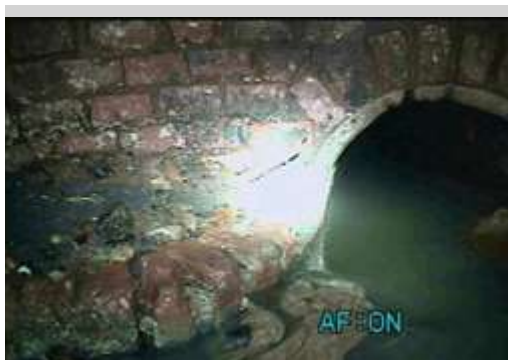
Misc. channel debris

channel debris

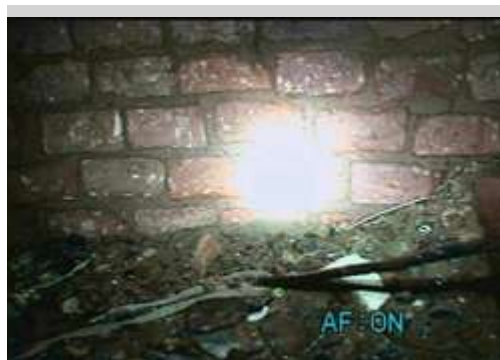
Misc. bench debris

bench debris

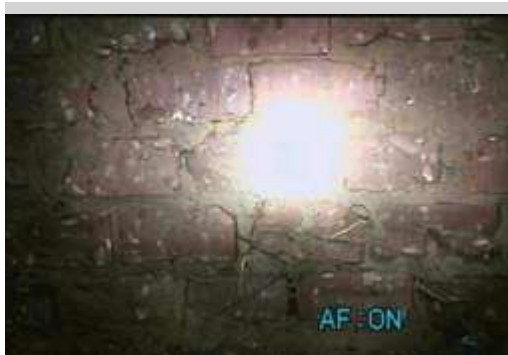
Defect 5

Condition: ☐ Sound ☐ Cracked ☒ **Root Intrusion** ☐ Loose Brick ☐ Deteriorated

roots in corbel

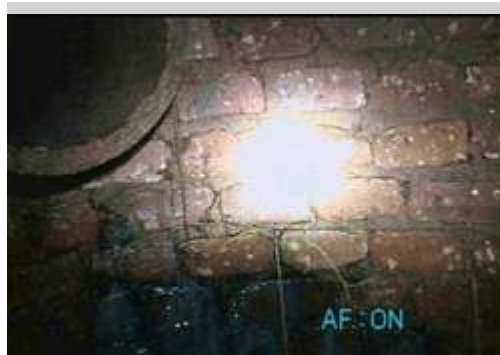
Defect 3

Condition: ☐ Sound ☐ Cracked ☒ **Root Intrusion** ☐ Loose Brick ☐ Deteriorated

Infiltration: ☐ None ☐ Joint ☐ Cracks ☐ Mortar ☒ **Roots** ☒ **Wall**

roots & infiltration in barrel

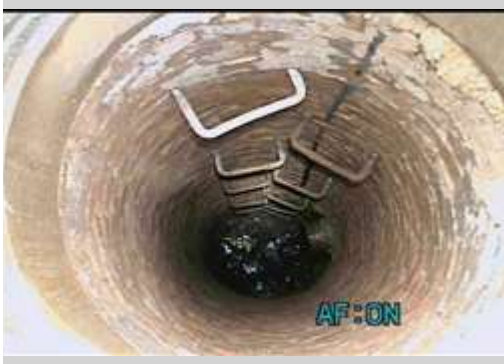
Defect 2

Count: **16** Missing: **0** ☒ **Corroded**

steps

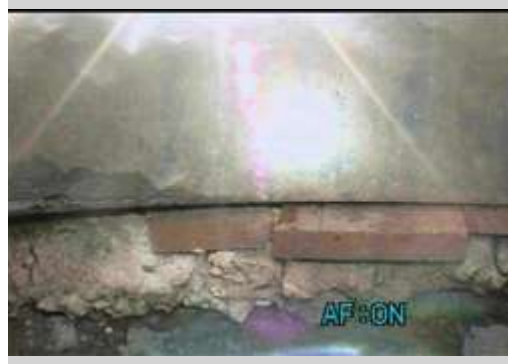
Defect 1

Condition: ☐ Sound ☐ Cracked ☐ Root Intrusion ☒ **Loose Brick** ☒ **Deteriorated**

chimney loose bricks and deteriorated;  
frame adj

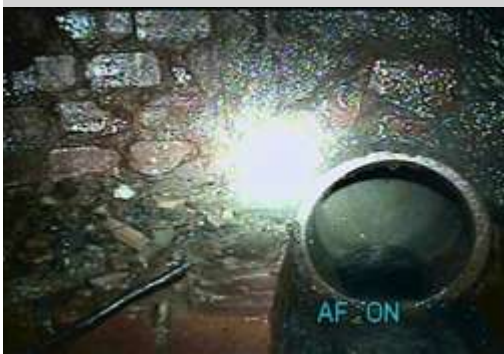
Defect 4

Barrel Wall Infiltration

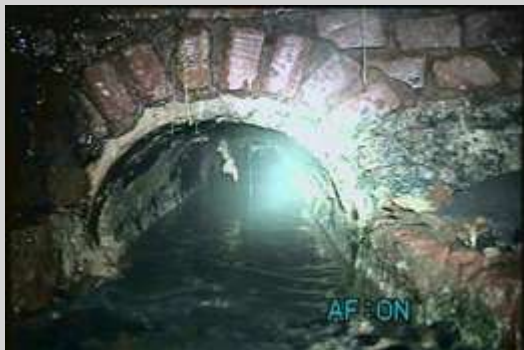
12 O'Clock Outflow

Infiltration: **Evidence** Pipe Seal Cond: **Roots**

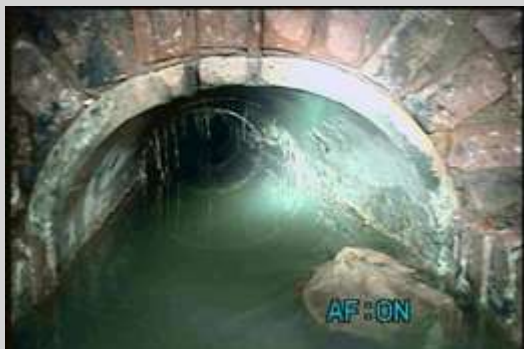
3 O'Clock Inflow

Infiltration: **Evidence** Pipe Seal Cond: **Roots**
